Given the harsh climate conditions (snow, rain, wind and ice) they must face, roofs easily deteriorate. Water infiltration through roofing is a very common problem in Québec.

RISK FACTORS

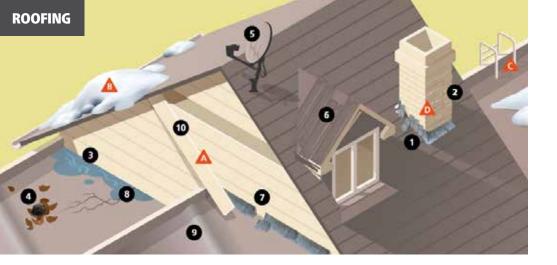
- Deformed flashing at the base of the chimney;
- 2 Missing mortar between bricks on the chimney;
- 3 An area of water accumulation (inverse slope = poor roof drainage);
- 4 A blocked roof drain;
- 5 Inappropriate installation of equipment (antenna, ventilation, etc.) on the roof;
- 6 Deterioration of skylight cladding;
- Evidence of rust on flashing.

- Missing flashing along the roof edge or on other roof structures (chimney, skylights, etc.);
- A fissure in the membrane (flat roof);
- 9 A bulge in the membrane (flat roof);
- An absence of shingles;
- A leaking skylight;
- Condensation due to a poorly or unventilated attic under a pitched roof.
